Slip-Sliding-Away... Soledad Mountain Road Landslide Remediation

by Dennis M. Poland, Director of Business Development
Anderson Drilling
Stan Helenschmidt, Principal Geotechnical Engineer
Helenschmidt Geotechnical, Inc.

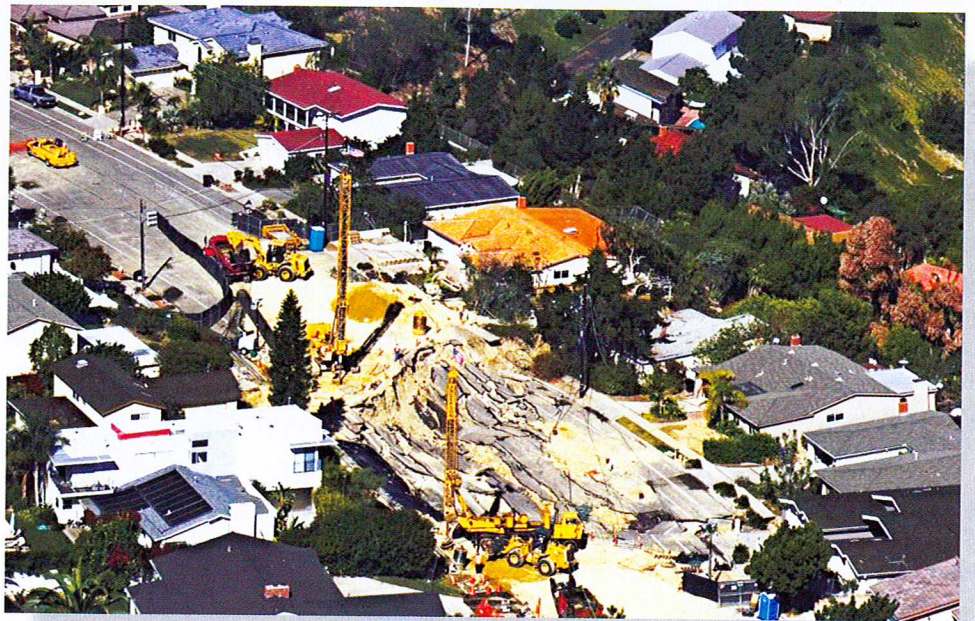
Anderson Drilling begins work on Phase 1 stabilization measures within 2-weeks of the catastrophic event.

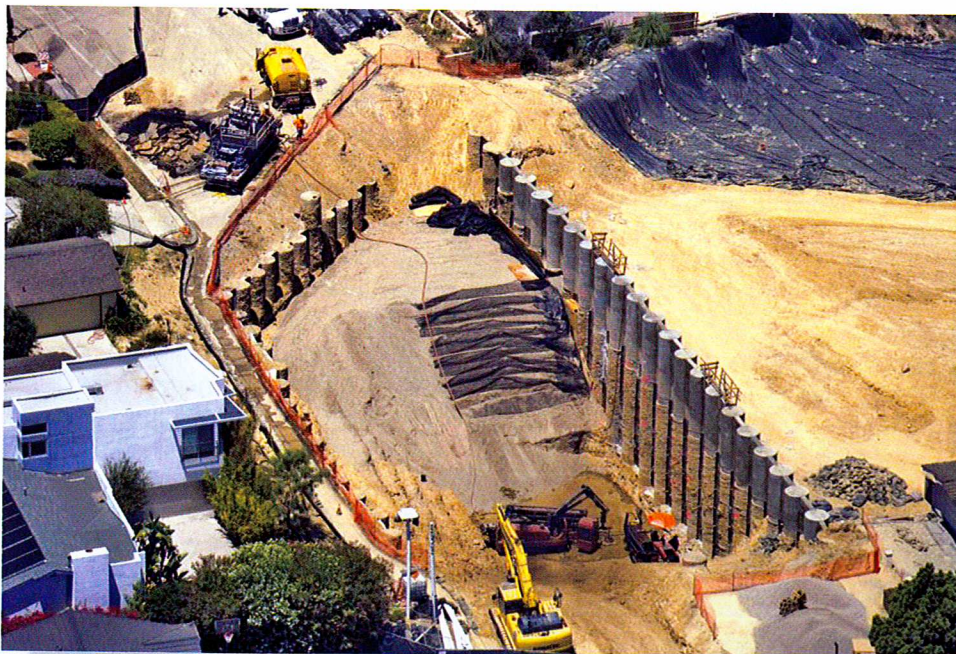
Aerial view of Phase 1 & 2 shear pin construction and slide debris remediation.

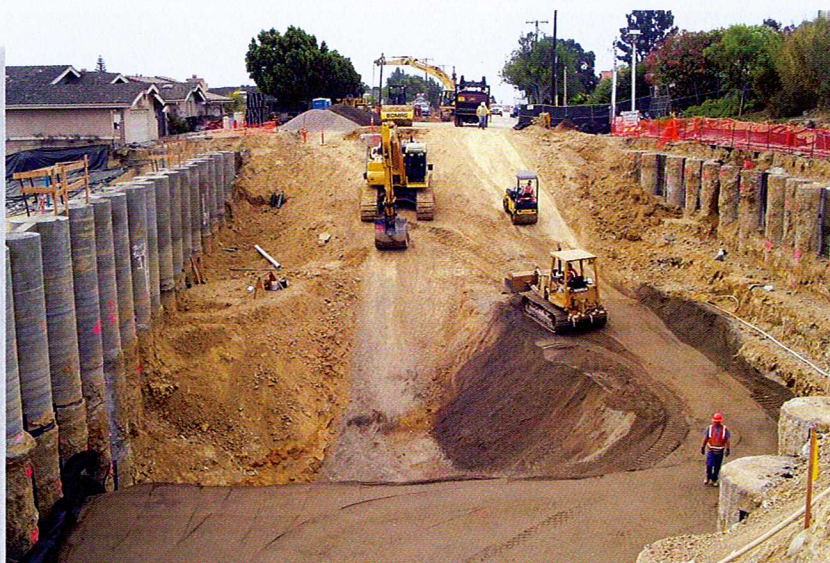
Landslide debris removal and shear pin key construction within the right-of-way.

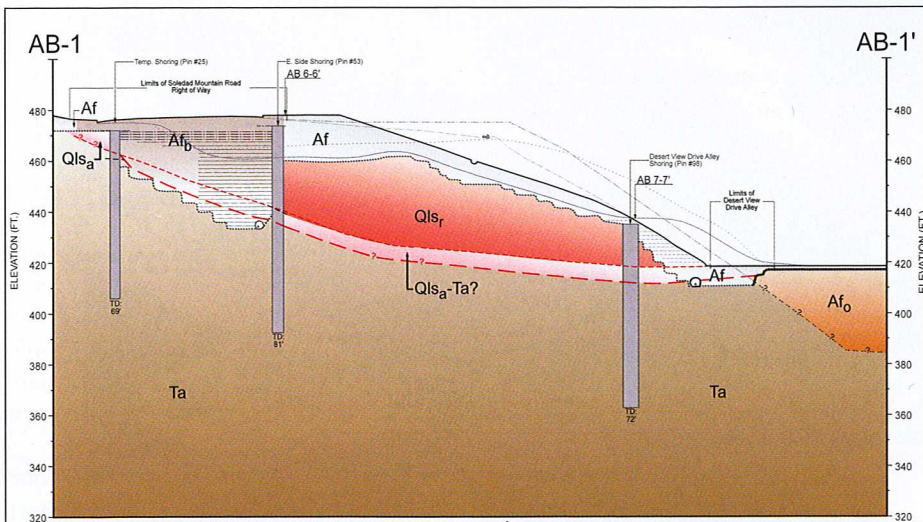
X-section of landslide repair scheme.

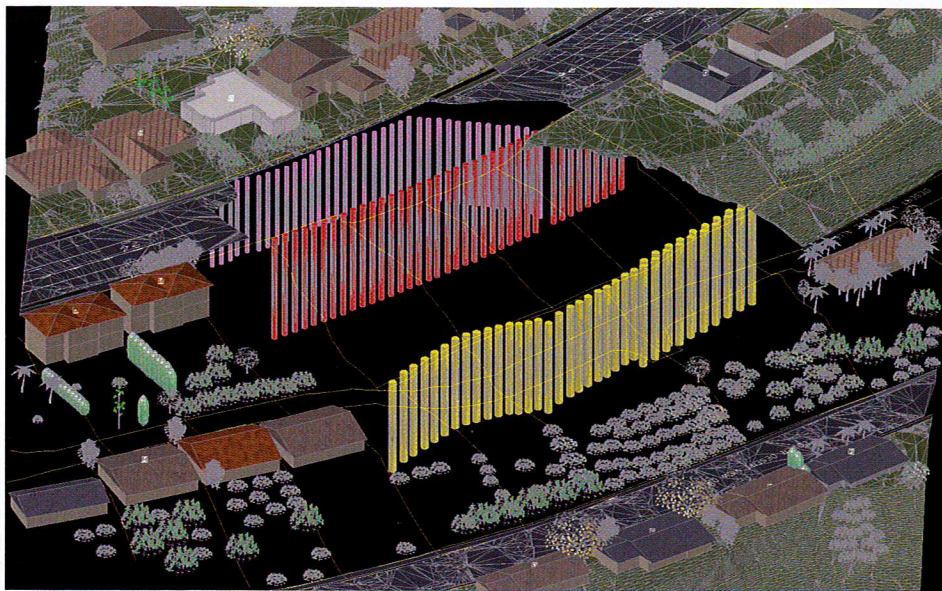
3D rendering of slide repair illustrating all three phases.

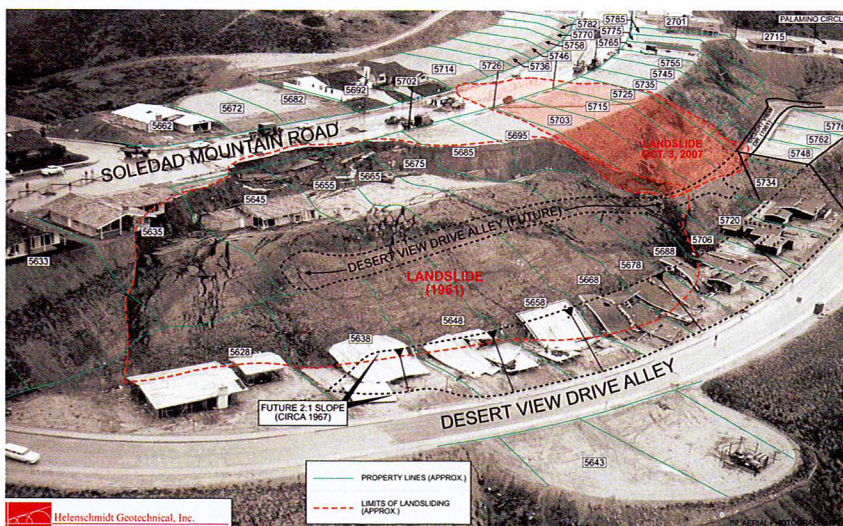
The October 3, 2007 landslide was part of an ancient landslide which was not identified during residential construction in the late 1950's and early 1960's. A similar landslide immediately to the south occurred in December of 1961 resulting in destruction of seven homes under construction. (See Landslide Overlay figure which identifies the 1961 and 2007 occurrences). Additional sliding occurred on the 5600 block of Desert View Drive

Proximity of 1961 landslide occurrence to the 2007 event shown in red.

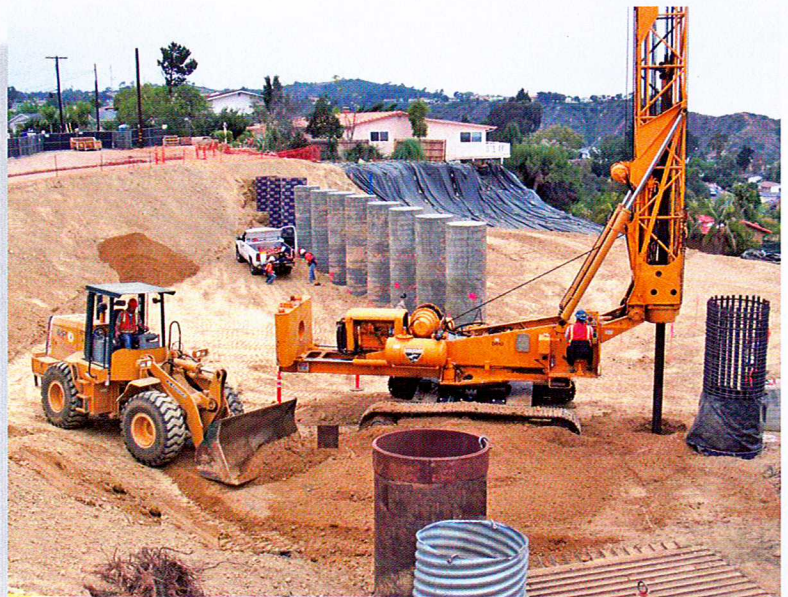
Installation of 54" diameter x 80 ft deep shear pins for Phase 2.

rig was performed with bobcat-type equipment. A total of 38 (54-inch diameter x 81 feet deep) pins spaced at 8.5 feet on center were excavated in a similar sequenced operation described in Phase 1 to control excavation exposure and permit subsurface logging. Reinforcing cages consisting of twenty six #18 bars and #4 spiral at 3-inches on center and weighing up to 36,000 pounds, were designed and fabricated to provide shaft rigidity. A 300-ton hydraulic crane was used to place these steel cages. With a

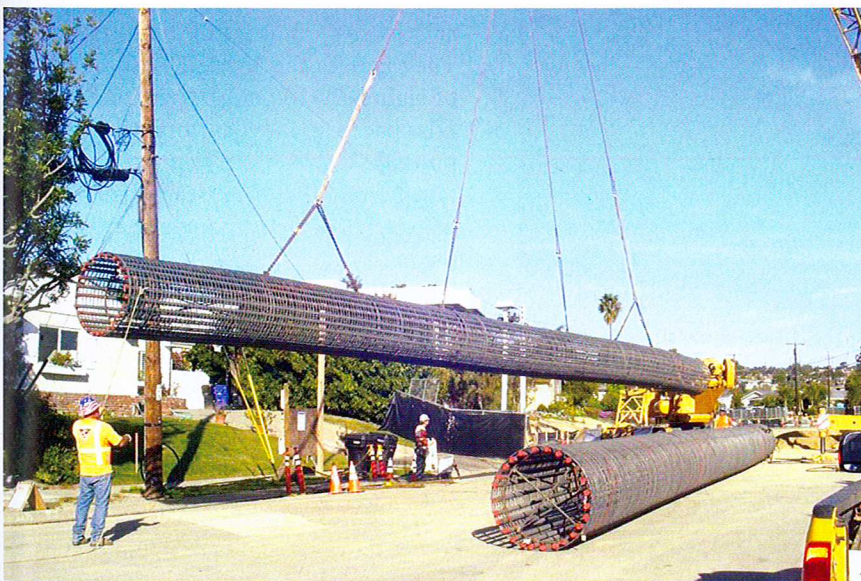
Phase 1 & 2 cages weighed up to 36,000 pounds.

The reinforcing cages for the 42-inch shafts were assembled with fourteen #18 vertical bars (2¼ -inch diameter) and #4 spiral (½ -inch diameter) spaced at 3 inches, total wt of 10,400 pounds. The cages for the 48-inch shafts consisted of eighteen #18 vertical bars and #4 spirals spaced at 3 inches, total wt of 20,760 pounds. Crews were kept at a safe distance from the slide scarp using a 52-meter concrete pump to deliver the 5,000 psi hard-rock concrete mix to each shaft location. Two inclinometers were installed in these perimeter pins to verify their performance during and after the phased construction.

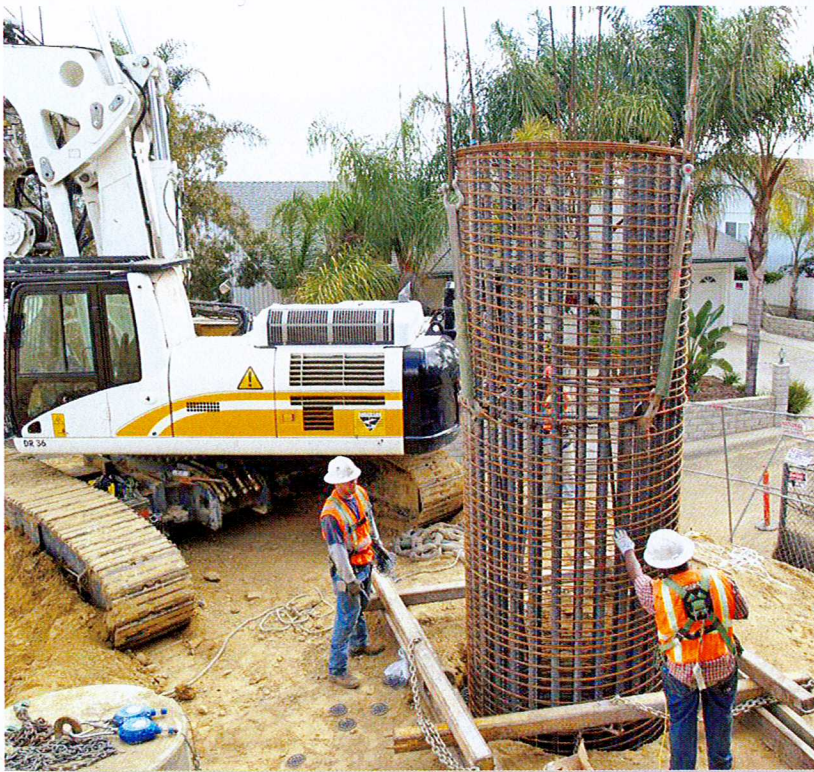
Installation of Phase 3 cages weighing upwards of 42,000 pounds.

Installation of the Phase 3 pins began November 10, 2008. The purpose of this work was to stabilize the hillside along the west side of upper Desert View Drive. Securing the base of the slide area was a critical step to allow for public safety when travelling on upper Desert View Drive. Helenschmidt Geotechnical, Inc. accomplished this by designing 44 (72-inch diameter x 80

feet deep) shear pins along the slide toe. This construction effort presented unique challenges due to the limited access to the site and tight space constraints at the work area. The street, more like an upscale alleyway, measuring approximately 20 feet in width, is bound by million dollar homes on the east side and an ascending slope with million dollar homes on the west side. This limited ingress and egress, as well as the size of our support equipment including: service trucks, loader, concrete trucks, concrete pump, crane and drill rig, made for a challenging working environment. The slide debris at the toe could not be removed until after the hillside was stabilized. A road was gingerly graded on top of the slide debris to provide access for our SoilMec SR60* drill unit, manufactured by ADSC Associate Member SoilMec S.p.A. The limited work space prohibited us from building the cages on-site or even having them delivered in close proximity to the shaft. The solution was to lift them from a delivery truck parked down below the work area on lower Desert View Drive. This solution stretched our reach requirements, up to 130 feet, and drove the crane size up. We determined that in order to hoist cages, weighing upwards of 42,000# from that lower street location, we could use a 300-ton hydraulic crane for the majority of the work but a 500-ton hydraulic crane would be necessary for some critical picks. A work pad engineered with a 9-foot thick geogrid reinforced earth mat was constructed in adjoining yard space between two of the damaged homes to support the cranes. Concrete was delivered to the shafts via a 52-meter concrete pump which was positioned as needed above the work area at along the now repaired (but not quite completed) Soledad Mountain Road. As with the other phases of installation, geologists performed down-hole logging to document subsurface conditions.

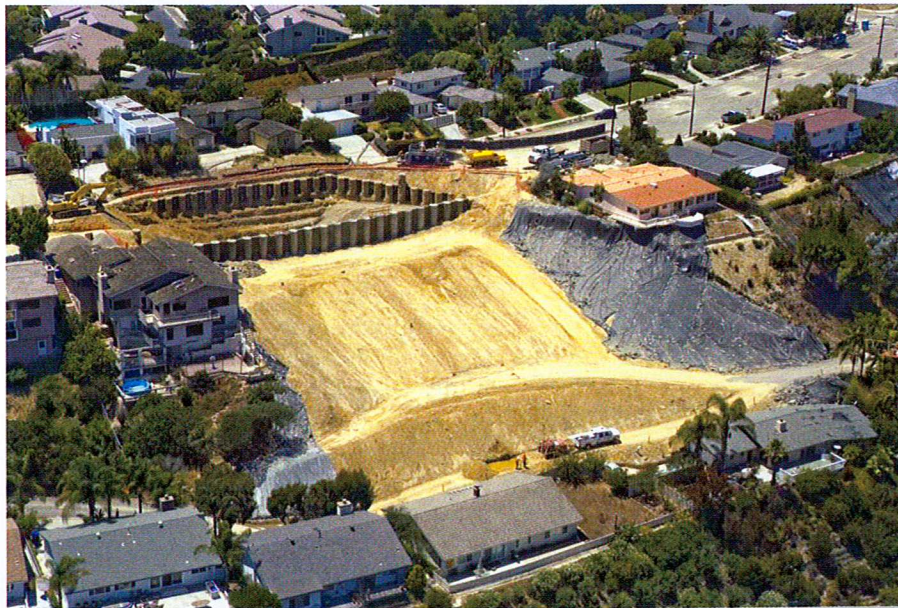
Phase 1 & 2 shear pin walls complete remedial slope grading and preparation for Phase 3.

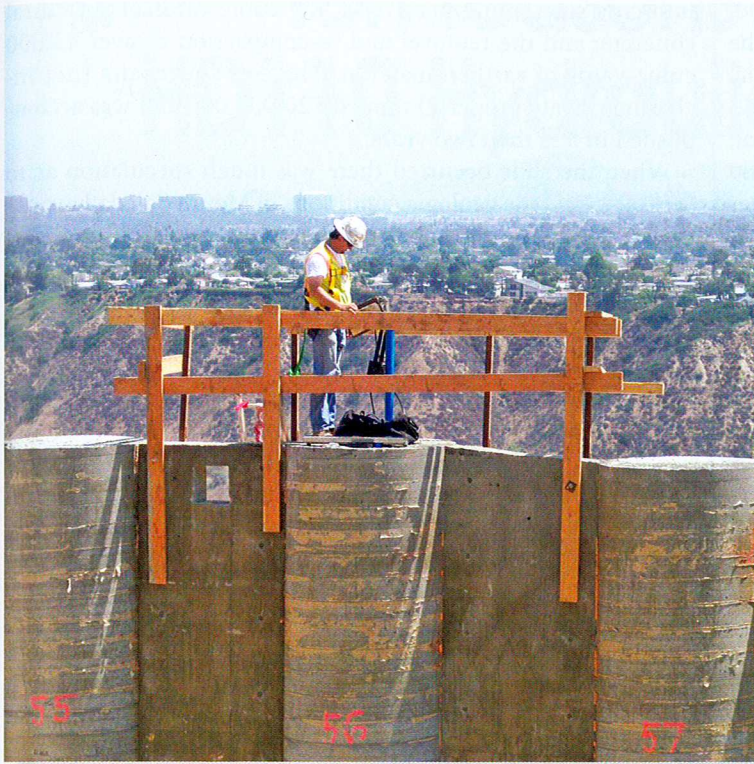
Monitoring pin deflection on Phase 2.

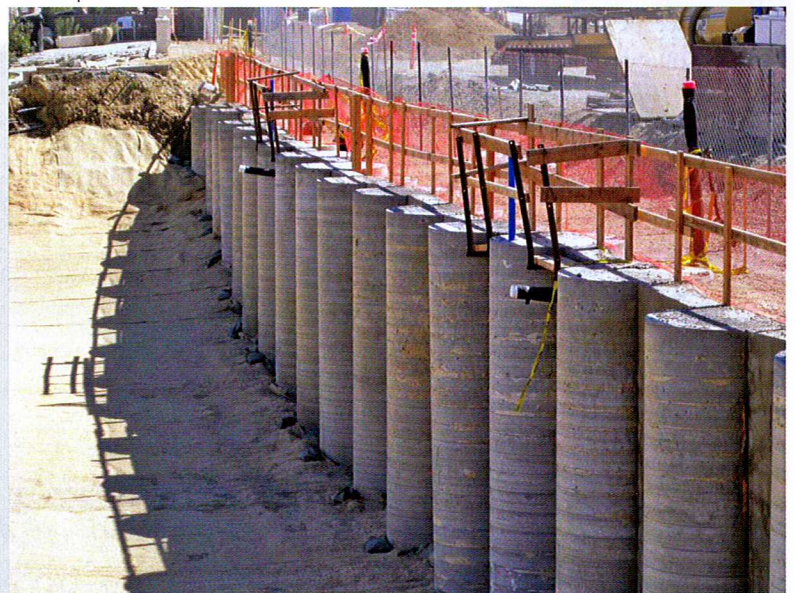
Phase 2 shear pin panel wall.

Once the shear pin installation was complete a 12-inch thick structural "lagging panel wall" was constructed between each exposed portion of pin allowing for engineered fill to be supported during the roadway reconstruction phase.
