Characterization and Stabilization of Reactivated Ancient Landslide, Soledad Mountain Road, La Jolla, California

ABSTRACT: Soledad Mountain Road transects Mount Soledad and provides one of the major accesses to La Jolla, California serving over 10,000 vehicles per day. On October 3, 2007, a catastrophic slope failure occurred along Soledad Mountain Road, destroying four homes and 61 meters of roadway and isolating eight homes from roadway access.

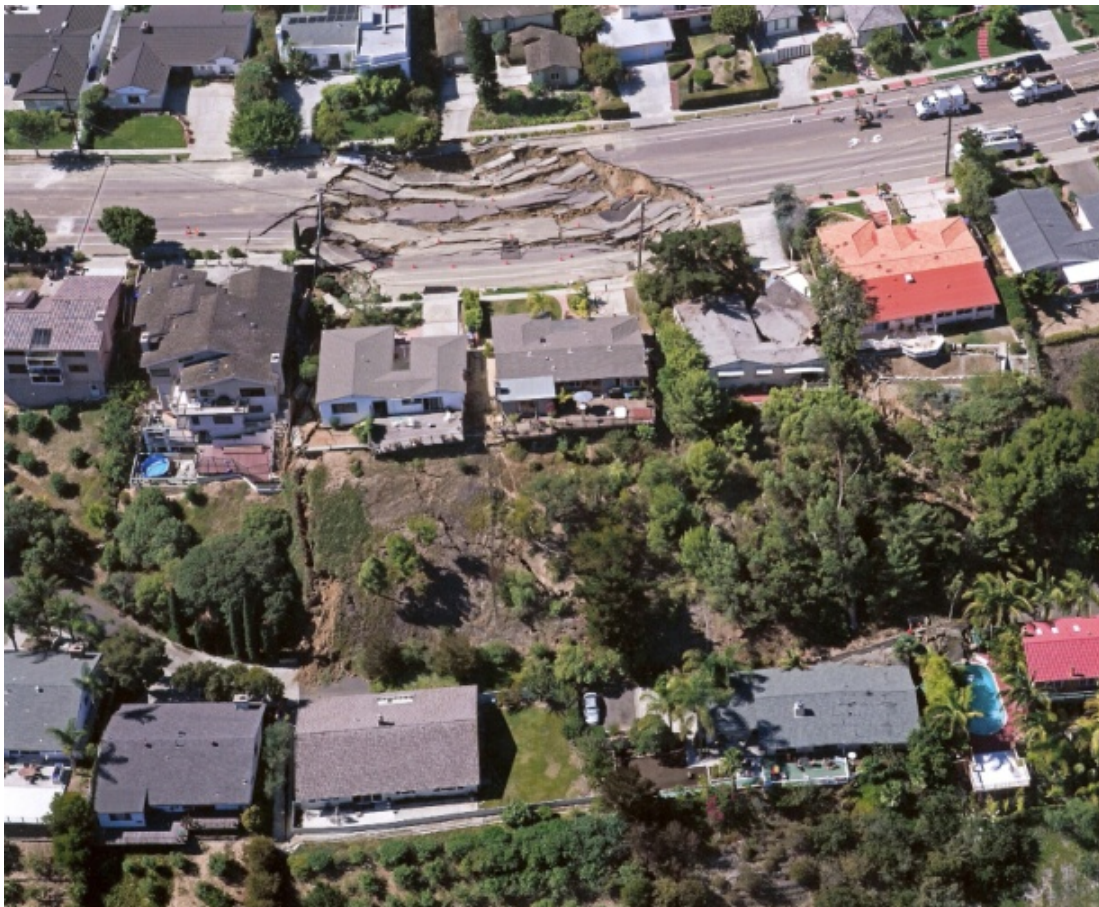
**FIG. 2. Aerial View of October 3, 2007 Landslide
Photo From Geo-Tech Imagery Intl.**

The landslide failed at approximately 8:50 am on October 3, 2007. A sudden drop of the pavement of approximately 15 mm occurred across the head of the landslide at Soledad Mountain Road followed by snapping of power lines. Several minutes elapsed prior to the major episode of displacement that resulted in translation of the residential structures 5703 to 5725 and rear yard slope approximately six meters toward the east and a drop in elevation in the street and building areas (5703 to 5725) of approximately three meters. Run-out at the toe area buried the front of the residence at 5734 Desert View Drive Alley and the alley was covered with up to 4.6 meters of landslide debris from the north end of 5720 to the south end of 5748. A free-standing wall at the east side of the alley at 5748 was also covered with landslide debris. The limits of the landslide are shown on the Geologic Map, Figure 5. A photograph of the landslide after the failure is shown on Figure 2.

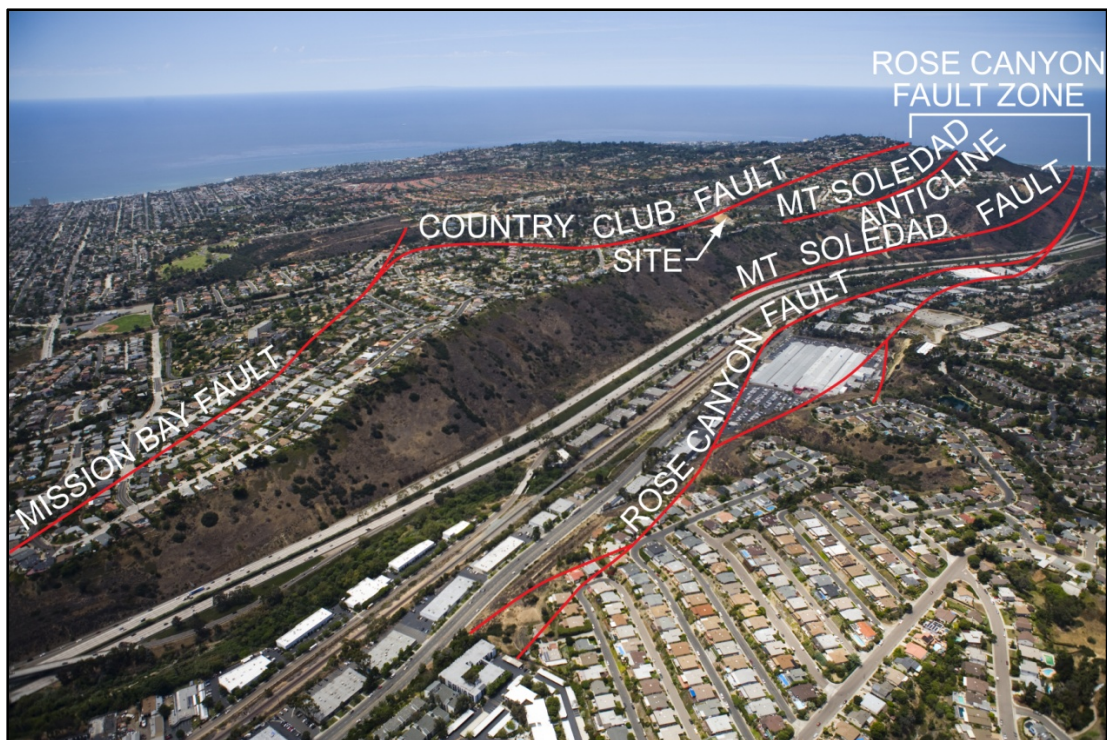
The site lies near the crest of the Mount Soledad anticline, a broad, asymmetrical fold resulting from compressional forces that developed along a bend in the Rose Canyon Fault Zone (Figure 3). Bedding attitudes shown on the geologic map of the La Jolla Quadrangle (Kennedy, 1975) generally indicate low to moderate dips of from 10 to 16 degrees to the east and southeast. These attitudes are in general

FIG. 3. Mount Soledad Faults
Base Photo From Geo-Tech Imagery Intl. (Annotation Added)

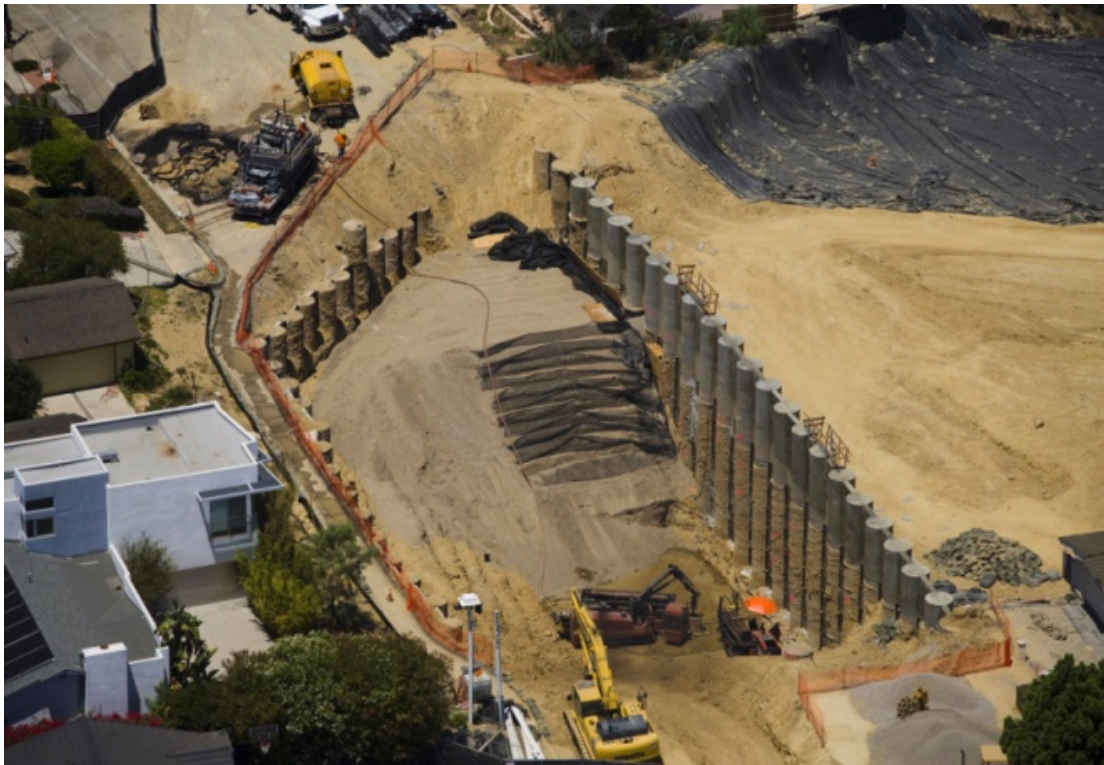
**FIG. 7. Roadway Stabilization (Looking North)
Photo From Geo-Tech Imagery Intl.**

Installation of stabilization features are pictured on Figure 7. Slope stabilization and repair of the Soledad Mountain Road Right-of-Way included installation of 75 CIDH re-bar reinforced concrete shear pins, 1.1, 1.2 and 1.4 meters in diameter, installed in two phases. The initial phase of shoring installation occurred along the west and north sides of the landslide mass, and consisted of 37 CIDH shear pins, 1.1 and 1.2 meters in diameter. This phase of shoring was designed for two primary purposes: to prevent westward expansion of the headscarp and associated damage to private property and to allow safe excavation of landslide debris within the right-of-way which would be hindered by existing shear surfaces. The second phase of shoring was installed along the east side of the Soledad Mountain Road Right-of-Way, and consisted of 38 CIDH shear pins, 1.4 meters in diameter. The purpose of this phase of shoring was to provide long-term slope stability of Soledad Mountain Road, to provide safe working conditions during removal and replacement of landslide debris and to support the temporary grade separation that existed between finished grade on the restored right-of-way and the ungraded private lots to the east which had dropped approximately 4.9 meters during landsliding.
